**Coastal Changes,
Eastern Lake Michigan, 1970-74**

William A. Birkemeier

MISCELLANEOUS REPORT NO. 81-2

**U.S. ARMY, CORPS OF ENGINEERS
COASTAL ENGINEERING
RESEARCH CENTER**

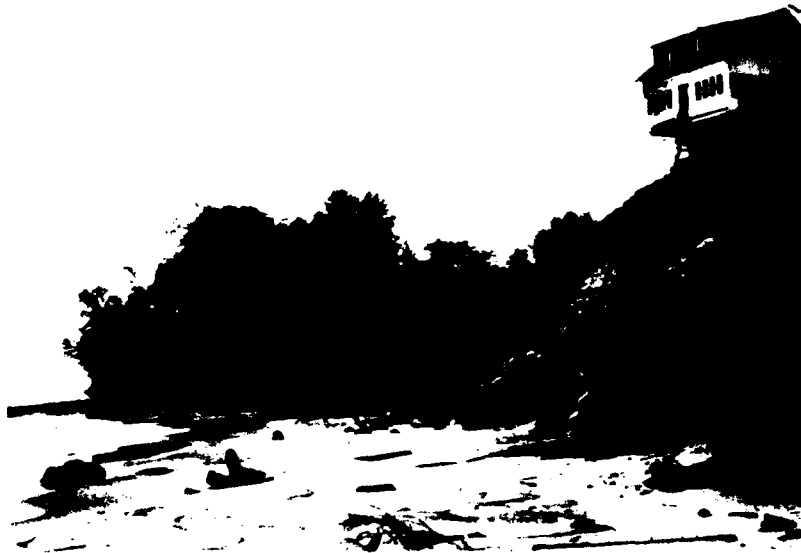
Figure 1. Severe bluff erosion undermining lakefront home near Stevensville, Michigan (17 October 1976).

Dramatic erosional changes along the shorelines of the Great Lakes (Fig. 1), which occurred during a rise in lake level from a low in 1964 to a peak level in 1973, sparked renewed interest in understanding and predicting the processes involved. An investigation of these changes began, under contract with the U.S. Army Coastal Engineering Research Center (CERC), in August 1970 with a series of monthly surveys of the 17 profile lines shown in Figure 2. The investigation continued until December 1974.

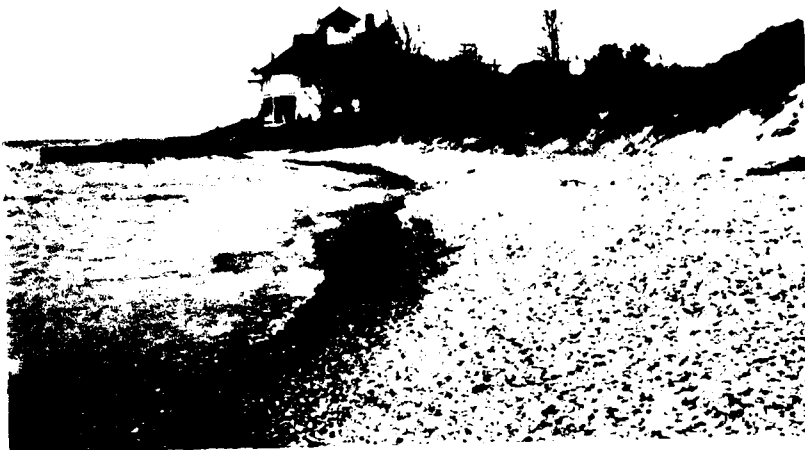
8 May 1973 - Note U.S. Coast Guard station and groins in background; also wide pebble beach.

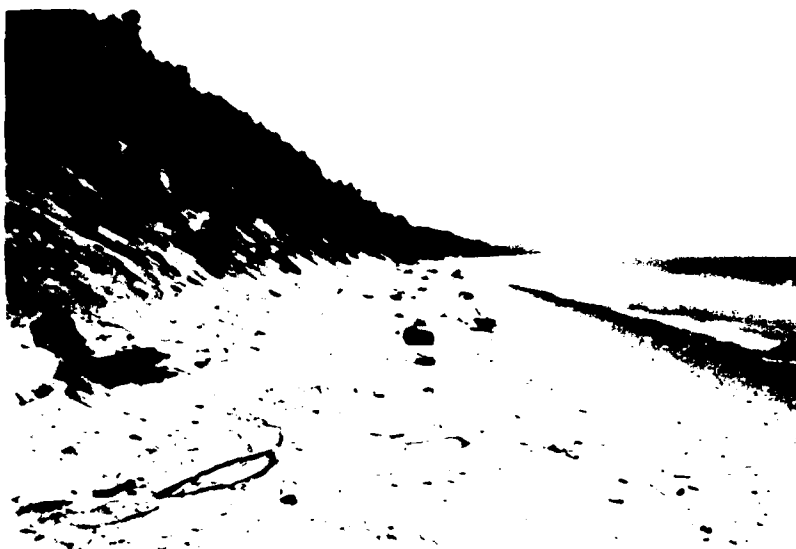
9 May 1976 - Sand and pebble beach decreases in width from the profile line to the south.

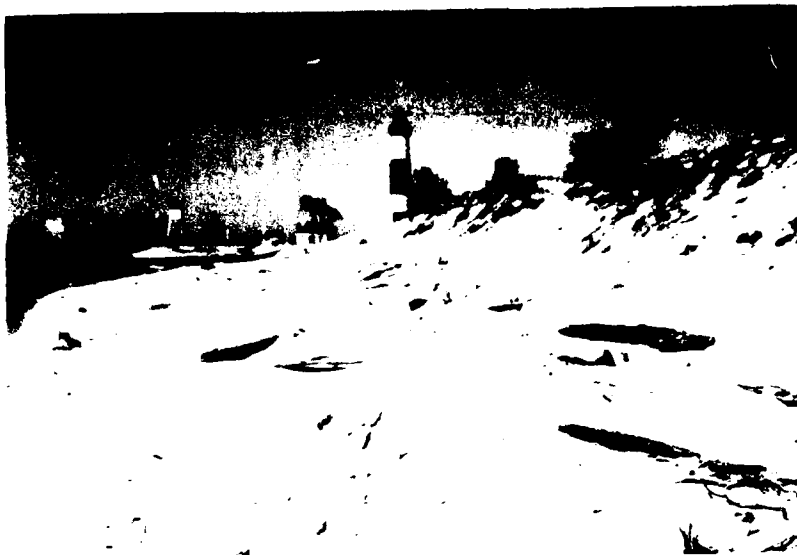
9 May 1976 - View to north showing wide sand beach. Note offset between beach and seawall (to left of white tower).

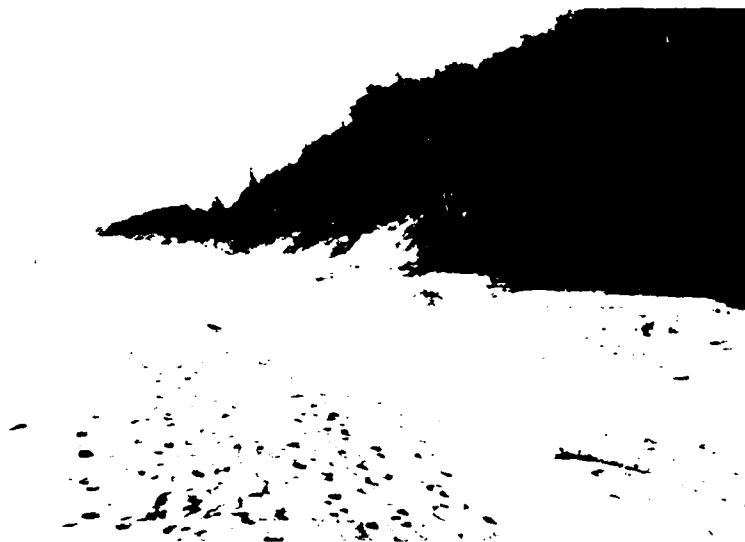
9 May 1976 - Wide beach in this photo is in marked contrast to photo below taken 2 years earlier.

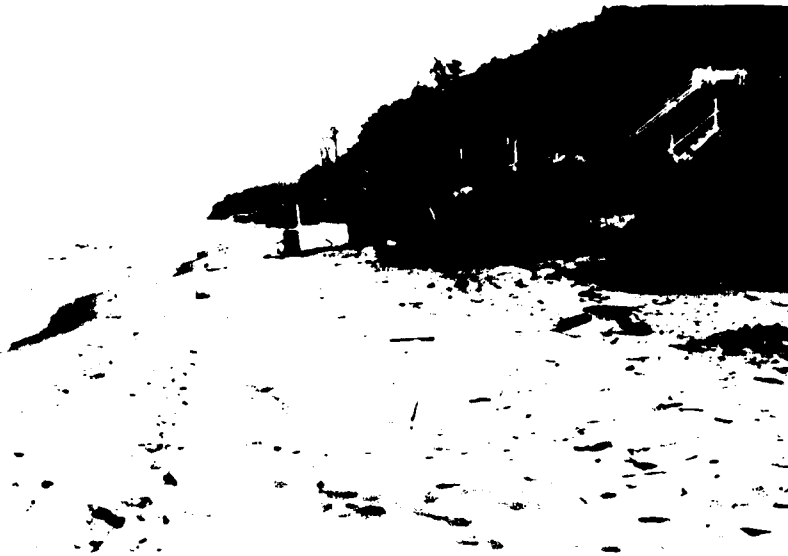
8 May 1973 - Wide sand beach, vegetated dune. Shack on beach and steep bluff face are evidence of recent erosion.

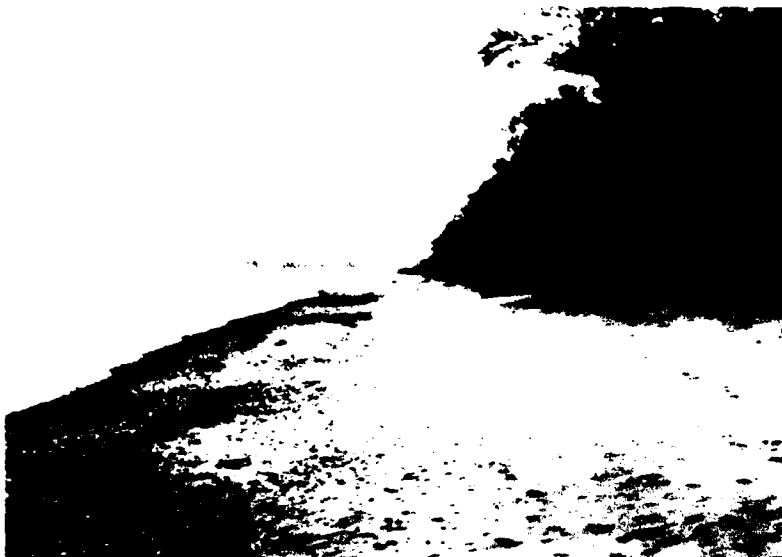
8 May 1973 - Wide, mildly sloping beach with gravel fore-shore. Note indentation of shoreline in middle of photo.
